Craig Clinic

Alaska Rural Primary Care Facility

Code & Condition Survey

October 7, 2003

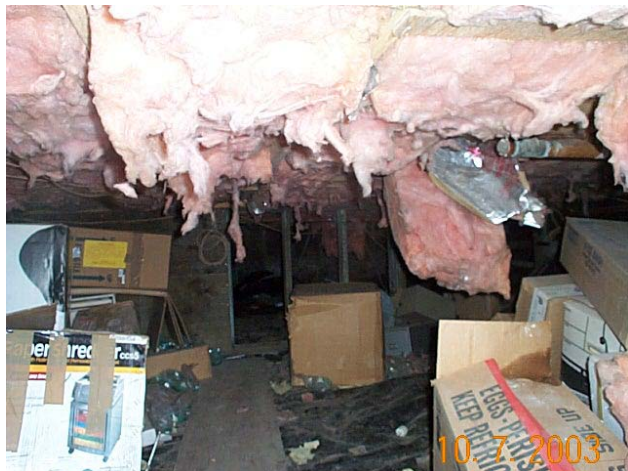
Acr01(A) & Acr02(A)

Architectural Deficiencies			
Item #	Code	Deficiency	Suggested Resolution & Rough Order of Magnitude Cost Estimate
Acr01	01	Flammable materials in the crawl space.	Remove all flammable items stored in the crawl space. (\$0)
Acr02	03	Floor insulation deteriorating and falling from the floor joists throughout crawl space.	Remove deteriorated insulation, replace and install support system to secure in place. (\$5000)
Acr03	03	Ceiling in Mechanical room has water damage.	Repair, patch and paint ceiling. The metal roof had been replaced recently so leak in roof has been apparently repaired. (\$2000)
Acr04	02	Exterior door hardware not compliant.	Replace all exterior door hardware. (\$2,000)
Acr05	02	Interior doors are too narrow into public spaces.	Replace all doors into public spaces with ADA compliant doors. (\$7,000)
Acr06	02	Doors do not have proper lever handles.	Install ADA compliant door handles on all interior doors. (\$9,000)

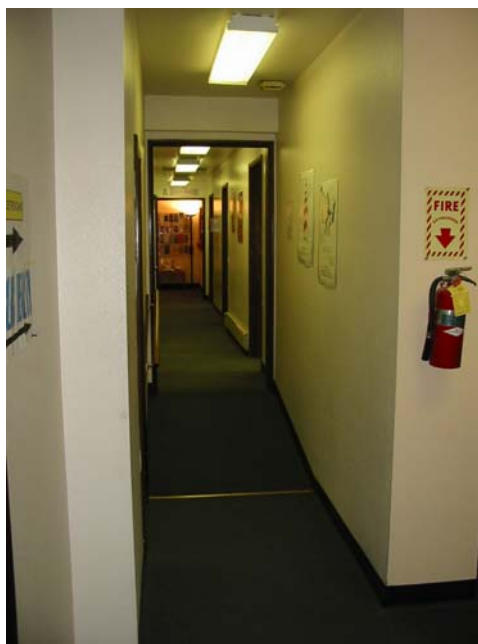
Acr07 & Acr08(A)

Acr07	02	Corridors in the original Public health Offices and the first addition are too narrow.	Redesign corridors to comply with minimum requirements of the code. The estimated construction costs for this deficiency is included in Acr18.
Acr08	02	Ramp from the original Public Health Office to the first addition is more than the code allows.	Redesign ramp to comply with ADA requirements including handrails. (\$10,000)
Acr09	02	Entrance door threshold at the S/E Public Health Offices is more than ½" above the entry (ramp).	Replace threshold or raise entry to comply with the ADA requirements. (\$250)
Acr10	03	No Arctic Entry at the Public Health main entrance.	Construct new Arctic Entry. (128 sq. ft. x \$200 per sq. ft. = \$25,600)
Acr11	03	No Arctic Entry at the Clinic entrance.	Construct new Arctic Entry. (100 sq. ft. x \$200 per sq. ft. = \$20,000)
Acr12	03	Cedar Shake roof has moss growing on it.	Replace Cedar Shakes with metal roofing to match the rest of the building. (3,971 sq. ft. x \$6.00/sq. ft. = \$23,800.00)

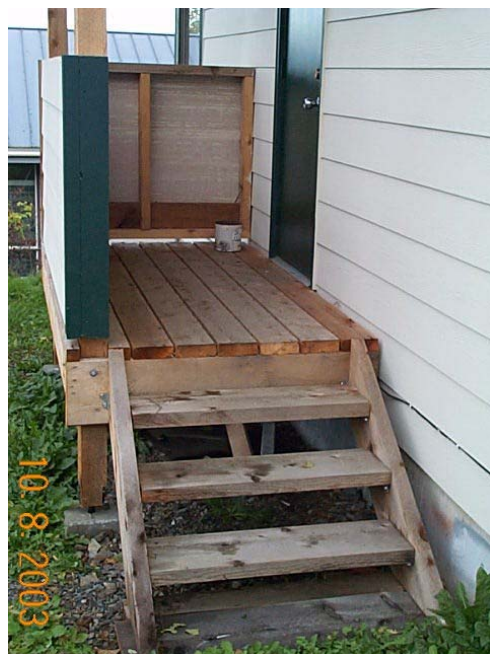
Acr14	02	No ramp at clinic entry.	Install ramp. (\$5,000)
Acr15	02	No hard surfaces at concrete ramp to emergency / trauma room,	Provide hard surface (approx. 20'x20') for emergency vehicle parking and off loading. (\$3,500)
Acr16	02	Hall too narrow.	Increase hall width to minimum 44". The estimated construction costs for this deficiency is included in Acr18.
Acr17	02	Door does not have minimum 18" on pull side of wall space for wheelchair and crutches.	Provide proper distance. The estimated construction costs for this deficiency is included in Acr18.
Acr18	02	Toilet room in PHN area does not meet ADA requirements.	Design new space for ADA compliance restroom(s) in PHN area. The cost estimate for this deficiency covers a 171 sq. ft. addition (see sketch A3) needed to accommodate larger ADA restrooms. In addition, this estimate covers other deficiencies in the adjacent areas affected by the changes to building wide finish upgrades. (\$60,000)

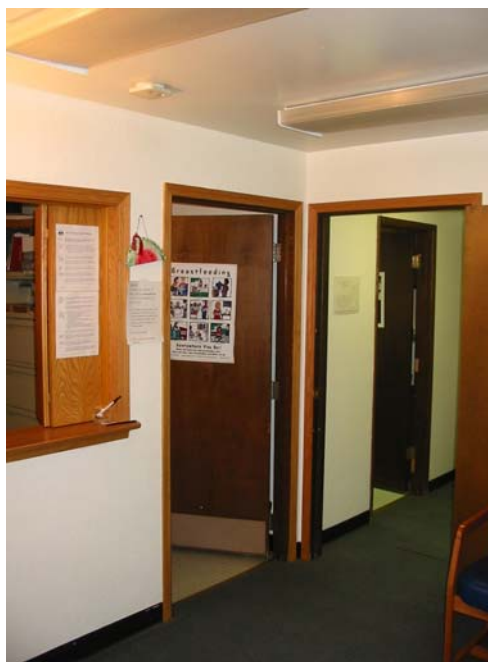
Acr19	02	Hall door does not have minimum 18" on pull side of wall.	Provide proper distance. The estimated construction costs for this deficiency is included in Acr18.
Acr20	03	Additional space is necessary for proposed renovation and expansion.	Add 574 SF at northeast corner of the building for addition of offices and exam rooms. (\$150,000)

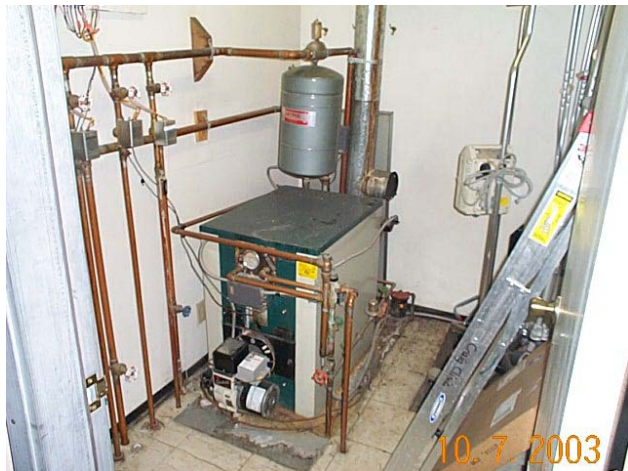
McCr01

Item #	Code	Deficiency	Suggested Resolution
Mcr01	02	The last State of Alaska boiler inspection of this facility was in 1998. State boiler inspections are required every 2 years.	Coordinate with the State of Alaska, Department of Labor, Safety, and Standards to have the boiler inspected. (\$0)
Mcr02	12	The boiler cold water fill does not have an approved backflow preventer.	Provide an approved backflow preventer on the ½" cold water fill pipe. The estimated construction costs for this deficiency is included in Mcr05.
Mcr03	02	Severe corrosion on the boiler stack may cause premature failure of this system.	Replace the 6"Ø all fuel chimney from the boiler up 10 feet to the roof penetration. The estimated construction costs for this deficiency is included in Mcr05.

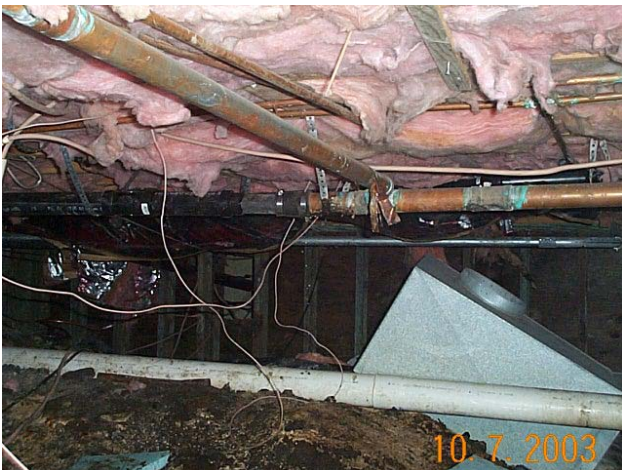
The sanitary soil, waste and vent system serves all the plumbing fixtures throughout the clinic. Pipe sizing has been determined to include a city sanitary sewer main, a 4" main from the clinic, and 4" or 2" branch lines serving the fixtures. Piping aboveground is DWV copper pipe with solder fittings with some cast iron soil pipe with no-hub fittings. There is an existing leak in the waste piping under the clinic in the crawlspace.

Mcr07	12	There is an existing leak in the waste piping under the clinic in the crawlspace.	Repair the leak in the 2" waste piping. (\$500)
Mcr08	12	The restrooms have been provided with plumbing fixtures that do not meet the ADA (barrier free) codes.	Provide ADA approved barrier free plumbing fixtures at all existing locations. Included are three water closets and three lavatories. Also provide an ADA approved pipe insulation kit for the waste, hot and cold water connections under the lavatories. The estimated construction costs for this deficiency is included in Acr18.
Mcr09	12	The waiting rooms, x-ray room, lab, and one exam room do not have an accessible operable window nor is there any ventilation system in the clinic to provide ventilation air to these spaces as required by code.	Provide a cabinet fan with heating coil and outside air connection so that a duct system with ceiling diffusers can provide air to this non-ventilated room. (\$1000)

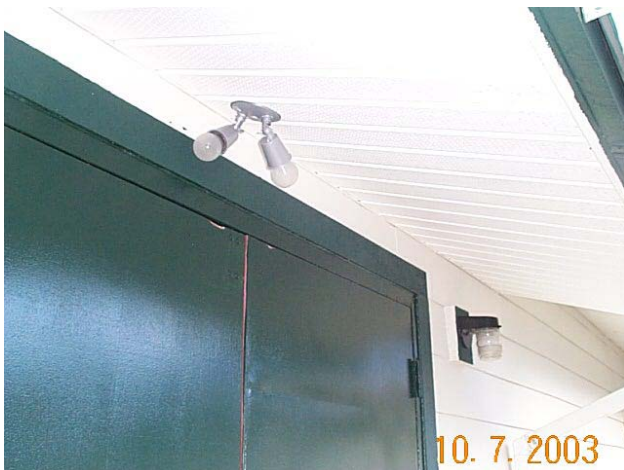
Ecr15	06	Several of the existing interior and exterior light fixtures are not functional.	Repair each fixture that is not functional. (\$500)

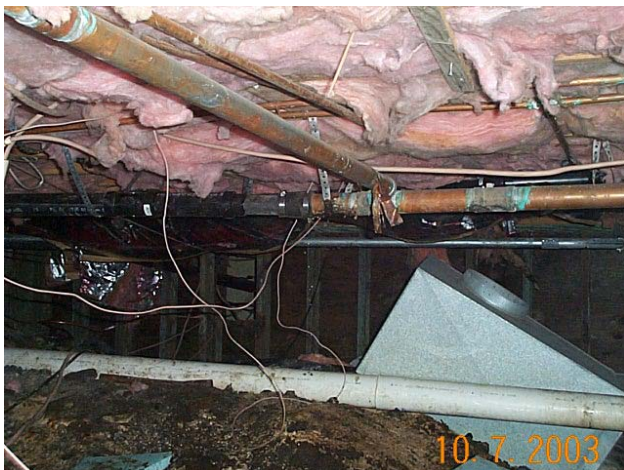
MGE07
Waste Piping in Crawlspace

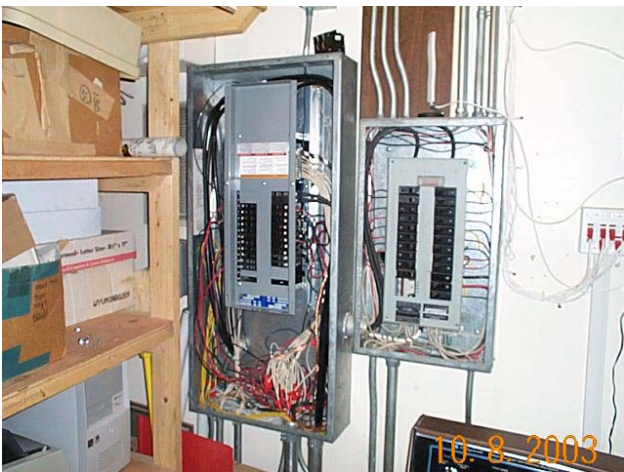
Distribution System: The MDP branch circuit breaker panel appears to also have been recently replaced at the same time as the new service. The panel has several code issues related to type NM cable possibly installed in patient care areas. The panels do not have adequate NEC required working clearances due to storage shelving located in front of the panel. The shelving should be removed to provide the required working clearances. Some of the conductors appear to enter the back of the panel through a knock with no connector or bushing protecting the conductors. These conductors appear to enter from the wall behind the panel with no raceway.

EGE03
Branch Circuit Panels

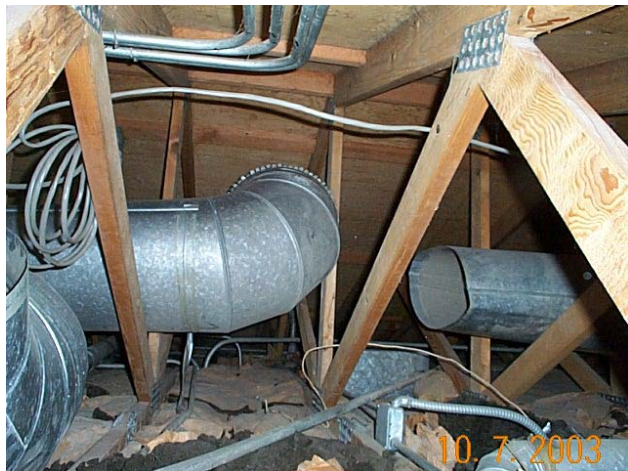
While inspecting areas above the ceiling and crawl spaces the use of type NM cable (Romex) was noted. This cabling system is not approved for patient care areas and must be replaced.

**EGE05
Attic Wiring**

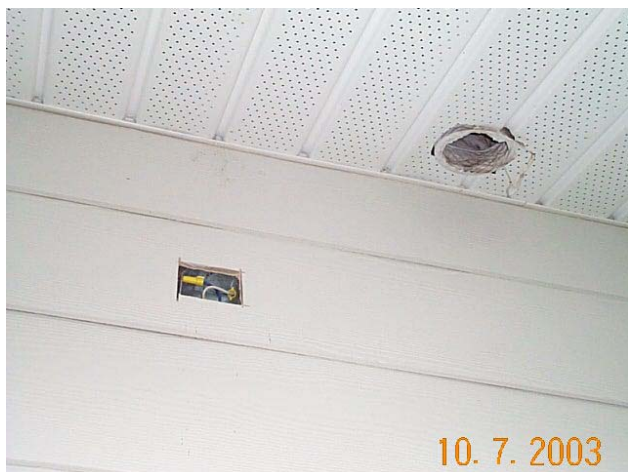
Open junction boxes were noted in the crawl space, attic spaces and mechanical rooms.

**EGE07
Open Junction Boxes**
